AFWAL-TR-87-4001

FAILURE ANALYSIS OF COMPOSITE STRUCTURE MATERIALS

May 1987

Final Report for Period of 1 October 1985 to 31 August 1986

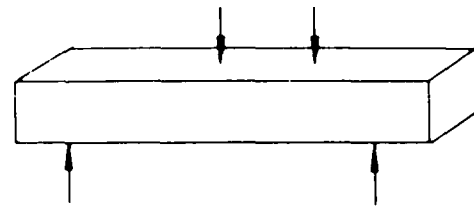
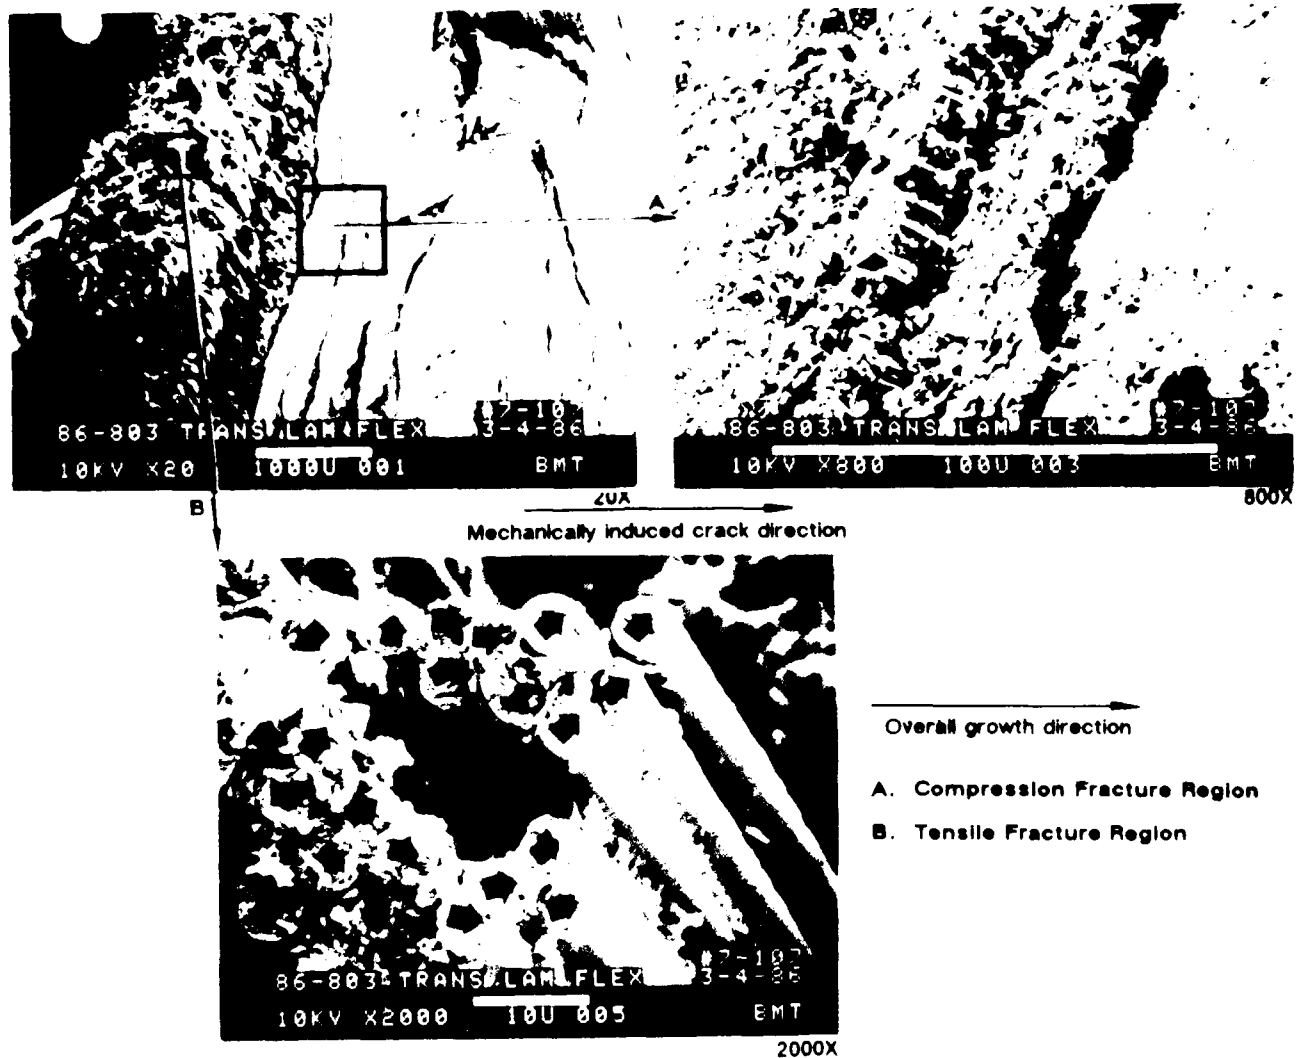
Figure 64. SEM Photomicrographs of Unidirectional 0-deg Laminate Flexure Specimen

In a manner similar to the singular translaminar compression failure specimens previously evaluated within this program, detailed examinations of the compressive failure surface revealed no morphological clues as to the direction of crack growth. However the tensile fracture zone exhibited features corresponding to the direction of crack growth. As illustrated in Figure 63, examination of the tensile area of fracture reveals a coarser pattern of lines running between the specimen edge and neutral axis. These lines appear analogous to ratchet lines often described in metals, where these lines are formed by the intersection of parallel zones of crack growth. Given this interpretation, these optical lines (see figure 63) suggest that crack initiation occurred at multiple locations along the specimen tensile surface and progressed inwards towards the specimen center. Evidence supporting this interpretation can be seen in figure 64 in which the direction of individual fiber breakage was found to occur parallel to the ratchet lines and towards the specimen centers.

In general, the fracture behavior of this specimen illustrates several notable considerations. First, ratchet lines appear to be a viable means of macroscopically determining the direction of tensile fiber fracture. This observation is particularly helpful because the scanning electron microscopic examination of fiber end fracture directions is tedious and time consuming. Secondly, line origins (multiple origins along one edge) exist in composites. This finding, while in itself not particularly surprising, demonstrates that potential investigators should be aware that crack initiation does not necessarily initiate at a single point. Thirdly, the dual compression/tension failure mode illustrates the limitations of our analysis methods. Since an origin for the compression fracture surface was unable to be identified, it remains unclear whether the tensile origins occurred before or after compression failure initiation. As a result, an accurate reconstruction of the sequence of failure could not be accomplished.

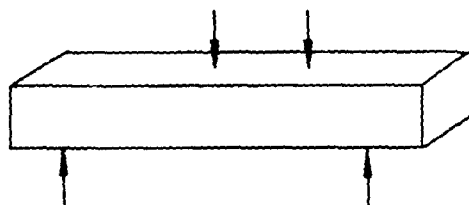
Figure 66. Interlaminar Fracture Surface Characteristics of the 0/90 Laminate Flexure Specimen

Inspection of delaminations on the tensile side of the specimen revealed that propagation occurred by inplane Mode II shear fracture. As presented in figure 66, scallop and hackle type features were observed throughout the specimen fracture surface. The direction of crack propagation for these features were assigned utilizing the same methods described for the compression after impact specimen. As shown,

delamination was found to initiate adjacent to the translaminar tensile fracture and progress axially down the specimen length.

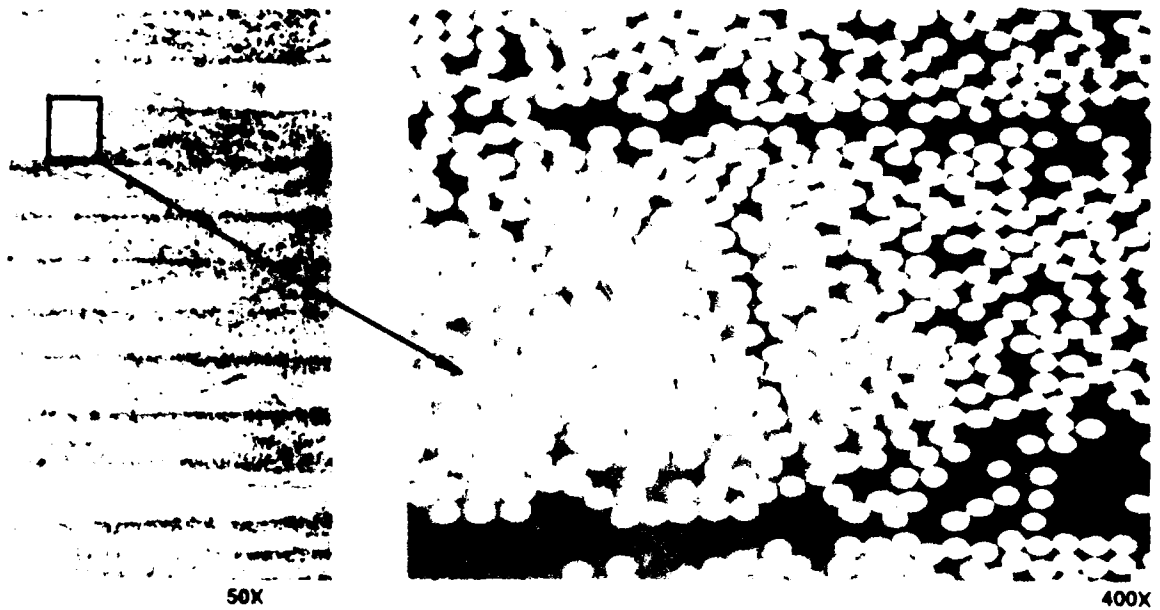
Figure 67. Optical Photomicrographs of Cross Sections From the +45/-45 Laminate Flexure Specimen

As discussed earlier, failure of this laminate orientation did not produce any discernable conditions of fracture. As a result detailed fractographic analyses of this specimen were not carried out. However, in order to better understand this specimen's behavior, optical cross sections were prepared parallel to the specimen axis. As illustrated in figure 67, examination of this specimen revealed multiple intralaminar microcracks parallel to the direction of fiber reinforcement. No interlaminar cracks were identified between the laminate plies.

Testing damage was limited to localized intralaminar cracking within the plies.

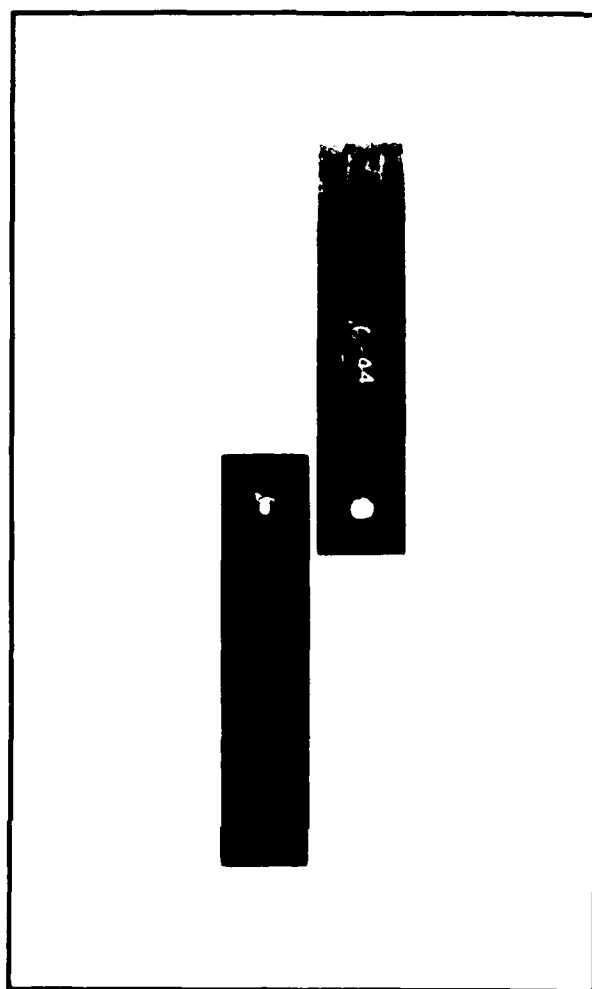
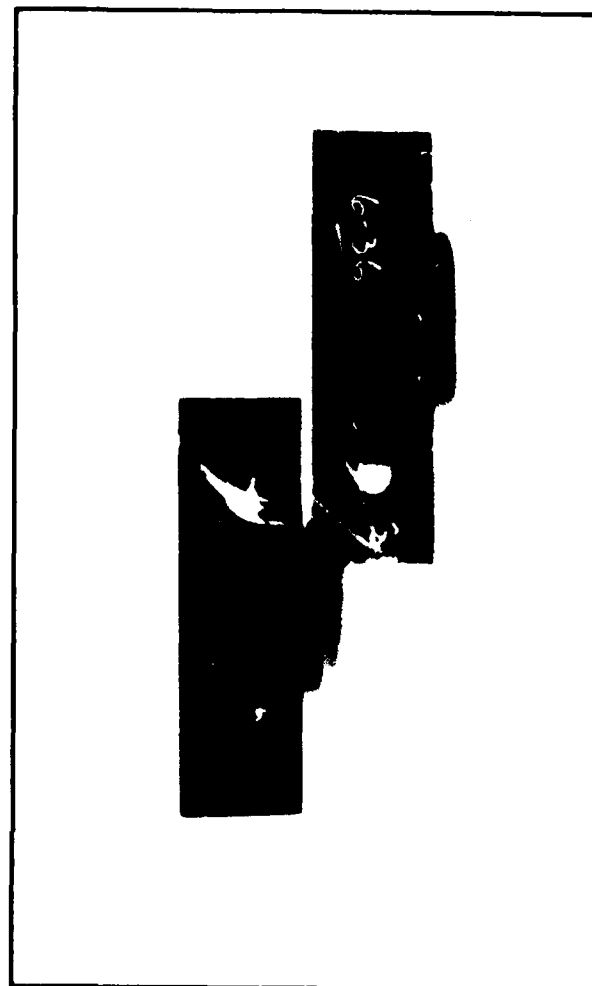
Figure 68. Overall Photomicrographs of the Fastener-Filled-Hole Tension and Compression Specimens Following Testing

overlap. Figure 68 presents the tension and compression overall photos following testing. Testing involved loading until joint failure, usually when the fastener had rotated and was pulled through a plank. Visual inspection of the tension specimen revealed extensive through-thickness translaminar bearing fracture where the fastener was dragged through the laminate during testing, as shown in figure 69. The direction of this damage with respect to the fastener hole was found to indicate the direction of axial loading (in this case, tension). As can be seen, a few surface plies were found to be delaminated and pushed up from the surface. No internal delamination damage was visually identified. Further cross sectional optical inspection indicated internal ply damage was restricted to the immediate fastener pull out region. The side view illustrated in figure 70 shows the lack of central ply delamination damage for the tension specimen.

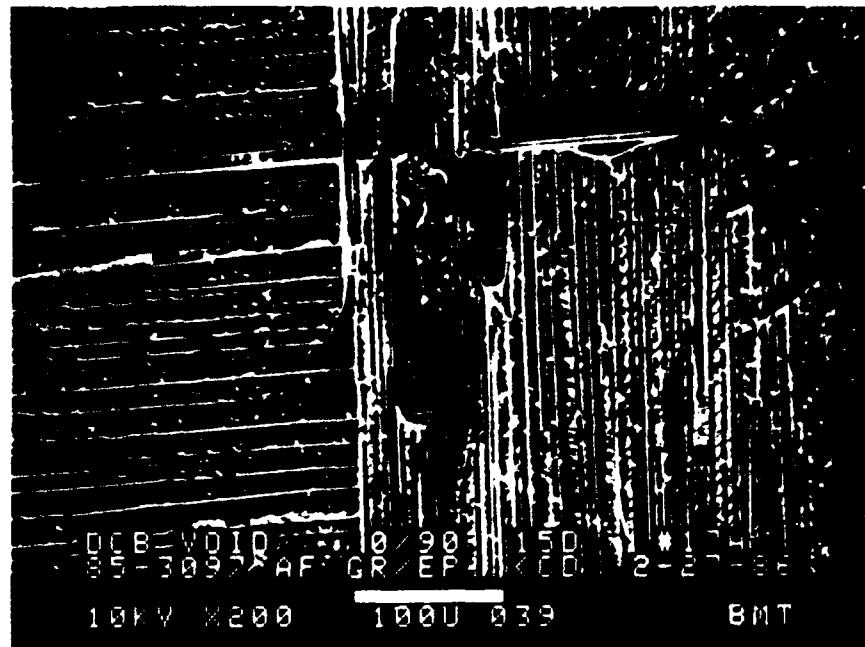
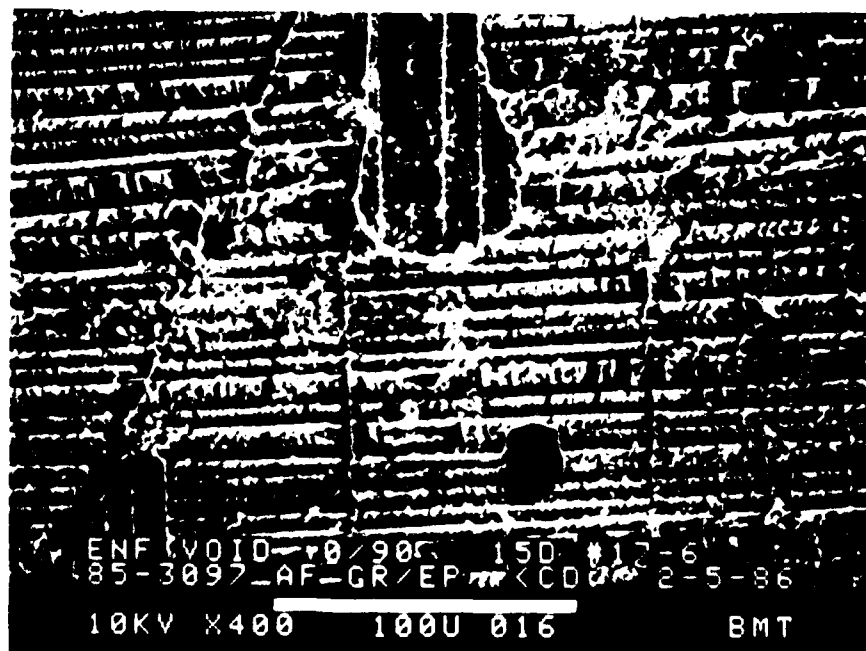
Figure 73. Typical Fracture Surface Morphology of Void Defect Specimens

Figure 73 illustrates the fracture surface morphology characteristic of delaminations produced in the void defect specimens. The voids were identified by both optical and SEM examination as semielliptical regions, with a large range in size. High magnification SEM inspection of the void region revealed a smooth, featureless, resin surface, with underlying fibers. The fracture surface surrounding the void regions exhibited a matrix fracture morphology typical of the induced mode (that is, DCB Mode I had river marks and ENF Mode II exhibited hackles). Therefore the effect of voids on the fracture process itself appeared to be minor, mostly a reduction in surface area involved in matrix fracture. Crack propagation directions for Mode I were coincident with the direction of imposed macroscopic fracture. The fracture mode for the DCB

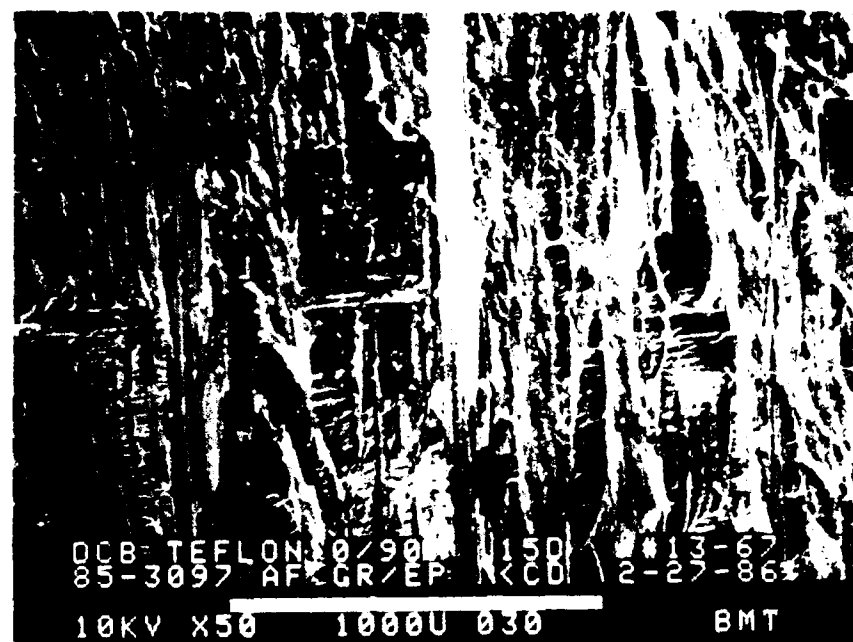
Figure 74. Typical Fracture Surface Morphology of Teflon Defect Specimens

Figure 74 illustrates the fracture surface morphology characteristic of delaminations produced in the Teflon defect specimens. The localized Teflon coated regions were characterized as interconnected and fibrous appearing, without resin fracture features. The fibrous appearance was elongated in the direction of wiping of the Teflon paddle during panel layup. The matrix resin fracture surface surrounding the Teflon regions exhibited morphologies typical of the Mode I and Mode II fracture conditions for the DCB and ENF specimens, respectively. Using river mark patterns in the uncontaminated regions, the crack propagation directions for the Mode I tension specimens were found to propagate in the direction of imposed macroscopic testing (away from the FEP implant).

*Note: The fibrous regions contain smeared
Teflon, which does not exhibit fracture details.*

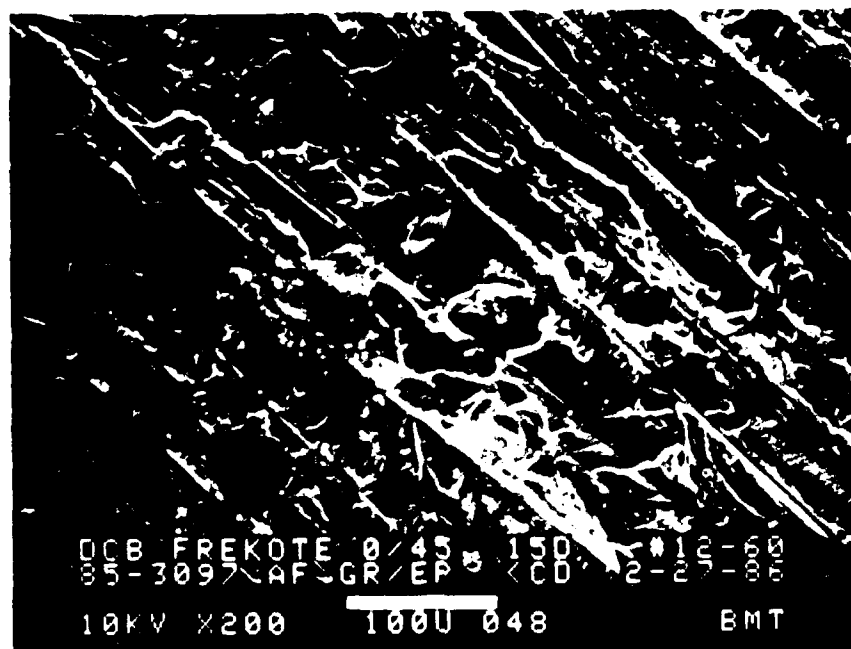
The large smooth regions are Frekote contaminated.
